POTTERSVILLE RESERVOIR DAM

NJ 00783

PHASE 1 INSPECTION REPORT
NATIONAL DAM SAFETY PROGRAM

MAY 1981

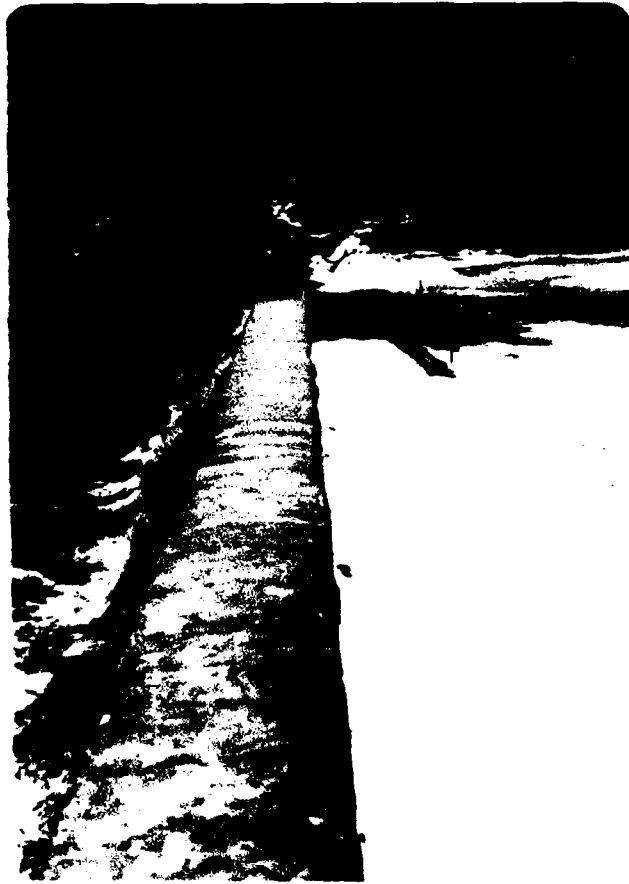
Photo 1 - View of dam from the left end. Two valve stems by wood plank control the flow to the chlorination building. The valve stem just to the right of the dam is for the low-level outlet. (Photo taken February 3, 1981).

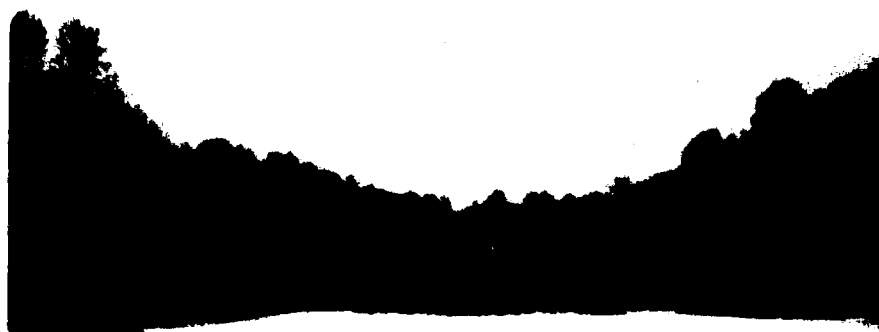
Photo 6 - View of reservoir taken from top of dam. (Photo taken January 9, 1981).

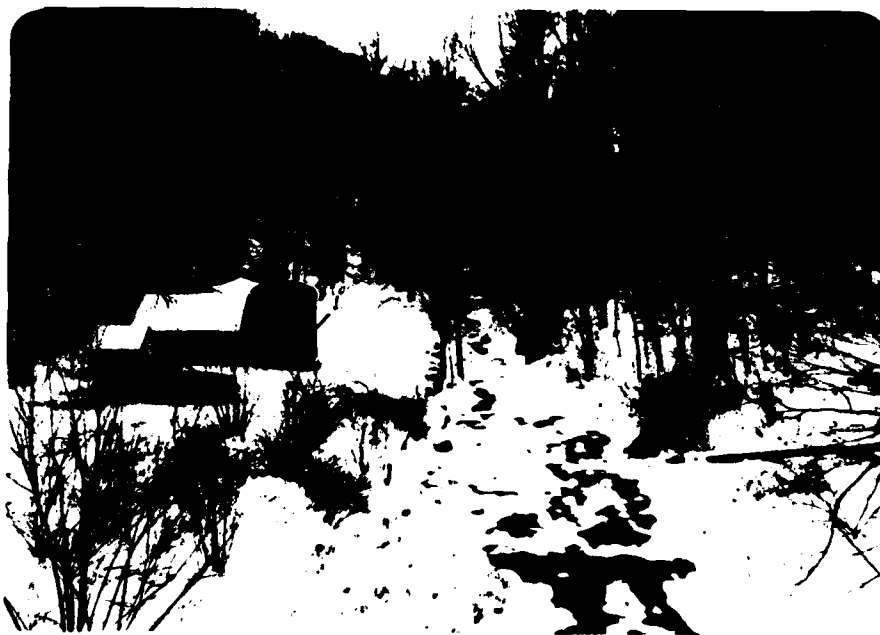
Photo 7 - View of downstream channel from top of dam.
Chlorination building is to the left.
(Photo taken January 9, 1981).
